FINAL REPORT:

FOR RESEARCH ON

**"PERFORMANCE TESTING AND ANALYSIS OF
RECYCLED AND NON-RECYCLED ADDITIVES IN
ASPHALTIC PAVEMENTS:
MICROSURFACING & RUBBERIZED ASPHALT"**

AUGUST 1996

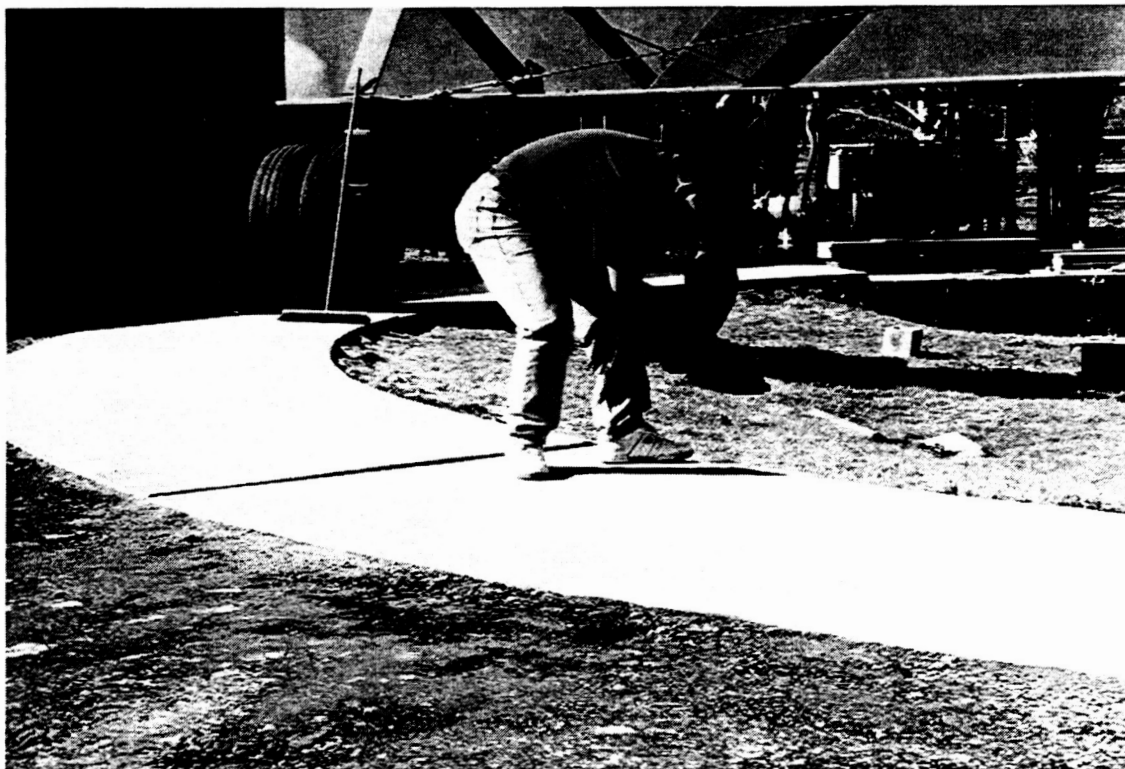
Photograph 3.2: Completed new fiber concrete track slab.

This new concrete was cured for seven days using sprayed water and a plastic cover. The outdoor temperatures ranged from 25 °F (-3.9 °C) to 65 °F (18.3 °C) during this cure process. The cured concrete is shown in Photograph 3.2.

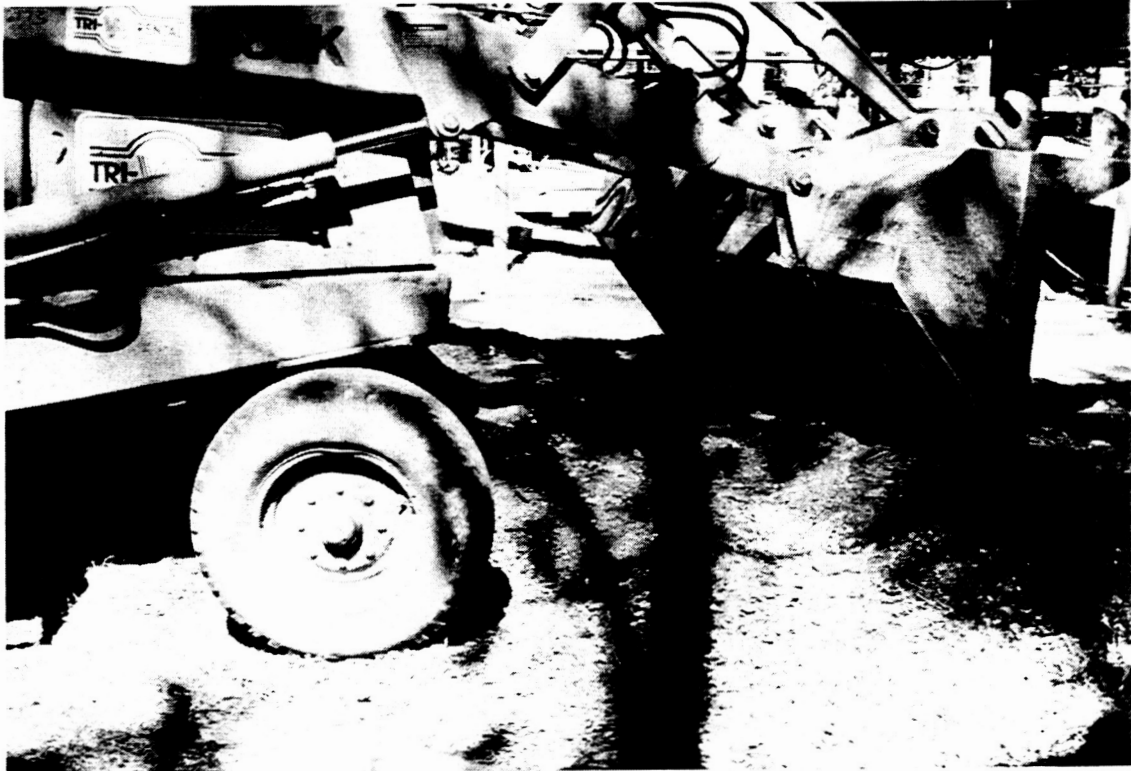
Photograph 4.2: Case 580K Backloader placing RAP around the track slab.

Before laying the testing asphaltic material, a local paving company was invited to prepare the west half of the test track by building up and widening the track slab to fit a regular paver machine. This was accomplished with three 25 ton truck loads of recycled asphalt pavement (RAP) and placed by a CASE 580K backloader, as shown in Photographs 4.1 and 4.2. The RAP was compacted with a 3 ton BOMAG roller, as shown in Photograph 4.3. An SS1 tack coat was applied to the concrete surfaces (see Figure 3 and Photograph 4.4) at pavement sections on C1.5, C1, R1 and R1.5 before the asphalt mixtures were placed. This tack coat is a very light application of a slow-setting anionic (electro-negatively charged asphalt globules) emulsified asphalt (asphalt cement and water) for a bond between the concrete slab surface and the overlaying pavement course.

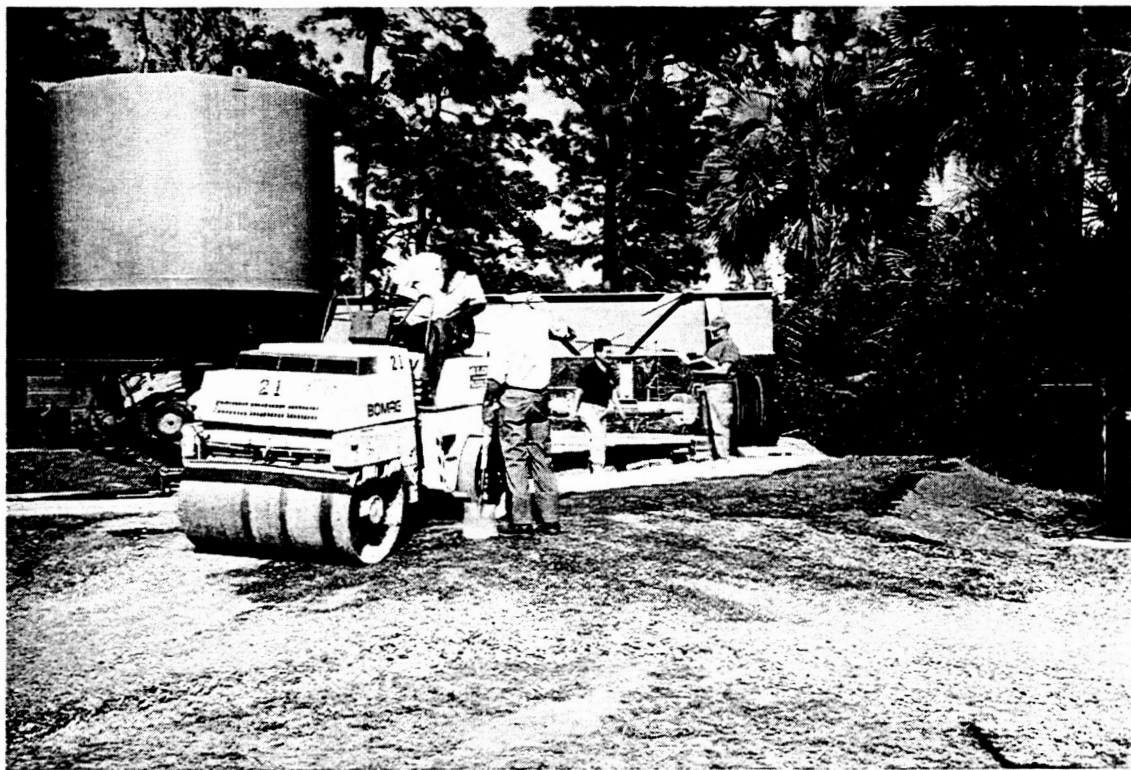
Photograph 4.3: BOMAG Roller compacting the RAP.

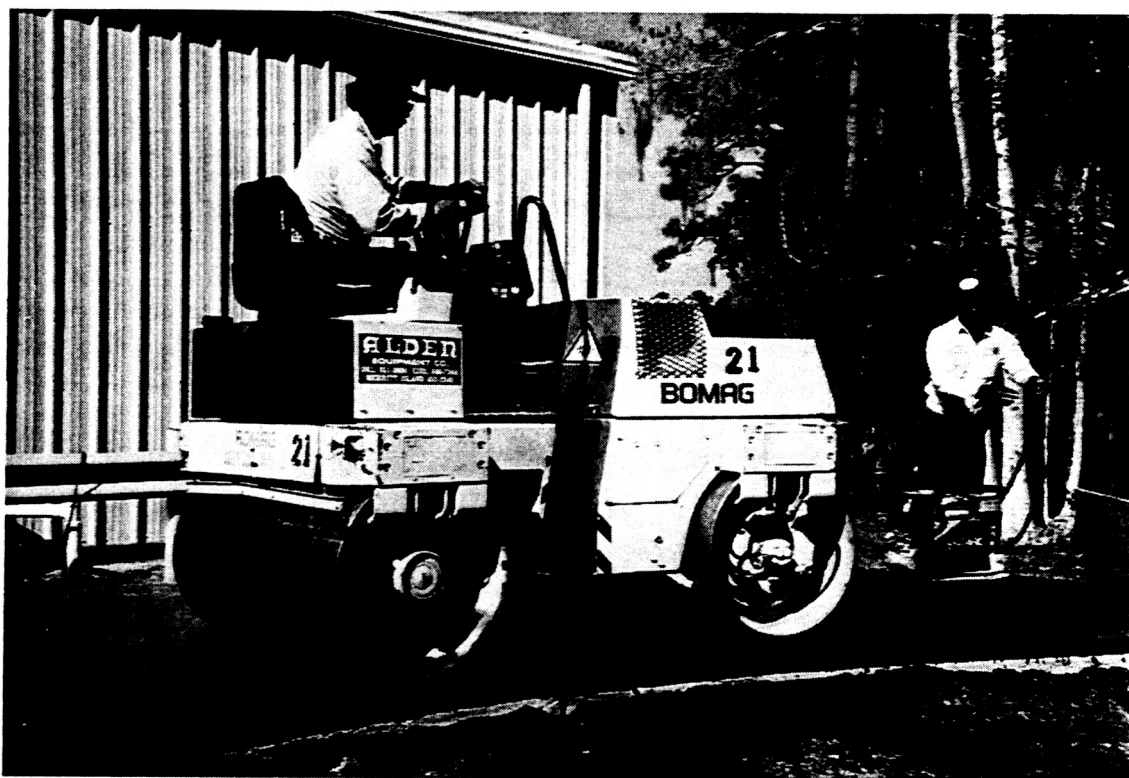
Photograph 4.8: BOMAG Roller compacting conventional mix (sections C1.5 & C1).

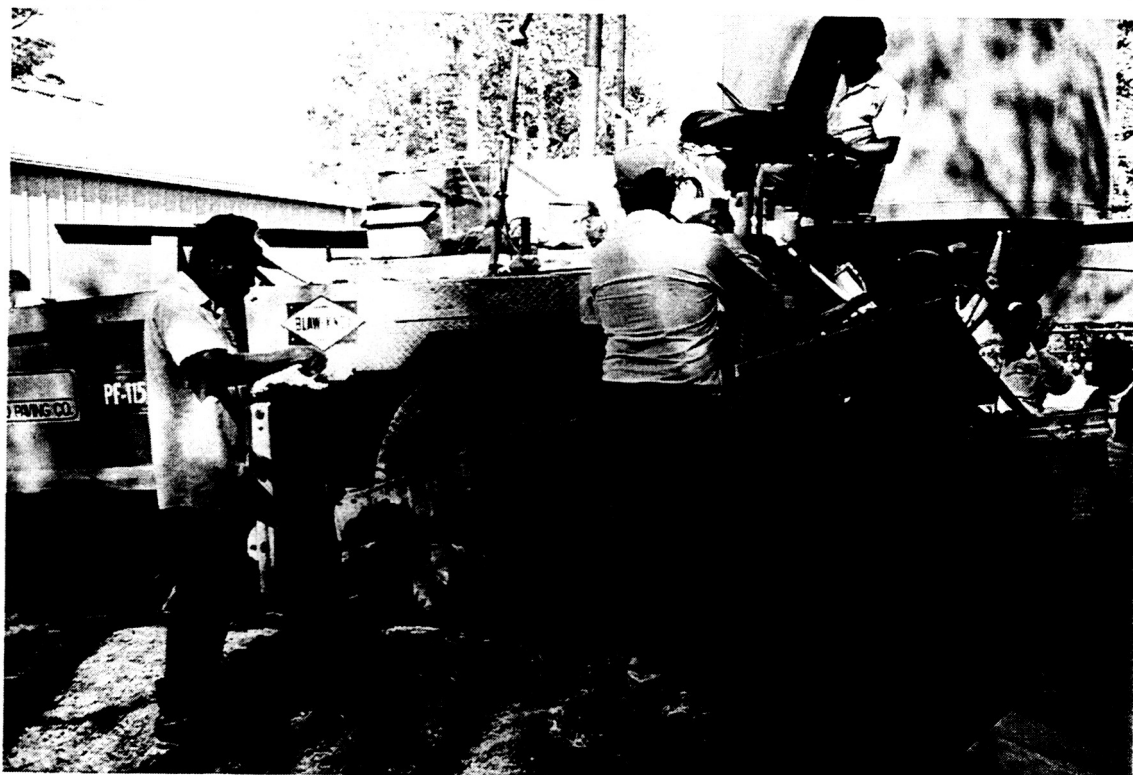
Photograph 4.9: PF-115 Paver and crew placing conventional mix (sections R1.5 & R1).

Rubberized asphalt mixture was placed on sections R1.5 and R1 using the same procedure as used for the conventional mixture, as shown in Photographs 4.9, 4.10 and 4.11. The average

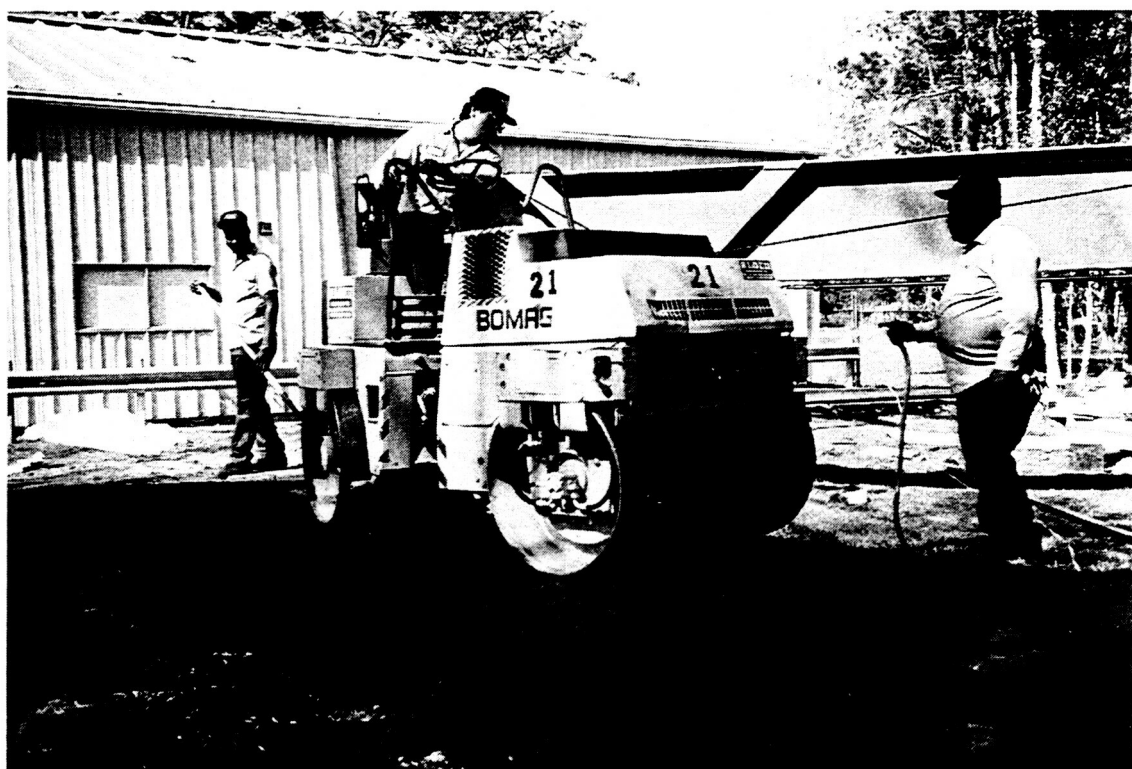
Photograph 4.11: BOMAG Roller compacting rubberized mix (sections R1.5 & R1).

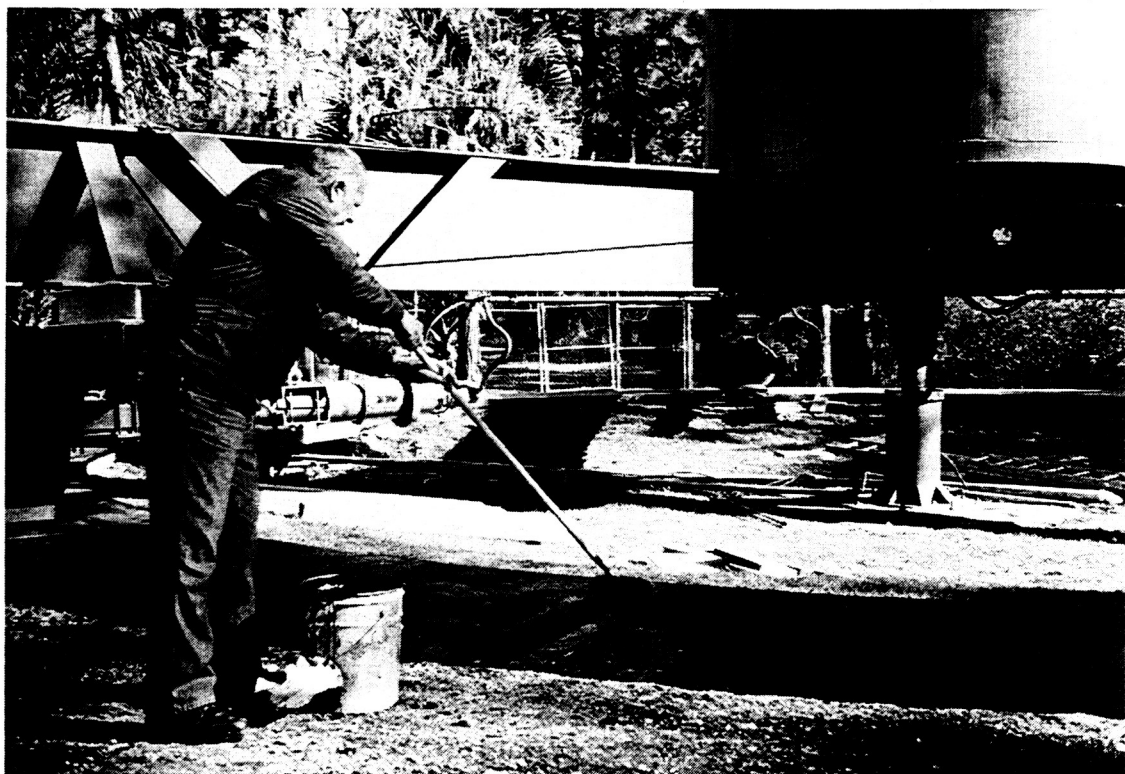
Photograph 4.12: Application of SS1 tack coat to concrete surface (microsurfacing).

Two material mixtures of microsurfacing, **GRIPLAST** (without fibers) and **GRIPFIBRE** (with fibers) were delivered as a Type II mix with 100% aggregate, 12% emulsion, 0.25% to 1.5% mineral filler, and 6% water. Before the mixtures were placed, the concrete surface was cleaned and applied with SS1 tack coat as shown in Photograph 4.12. **GRIPLAST** was laid first by the BERGKAMP continuous mix paver (without the hopper). This dark brown **GRIPLAST** flowed quite easily. Handwork using rakes and burlap was necessary to meet a required uniform thickness. Photographs 4.13 and 4.14 show the sequential procedures.

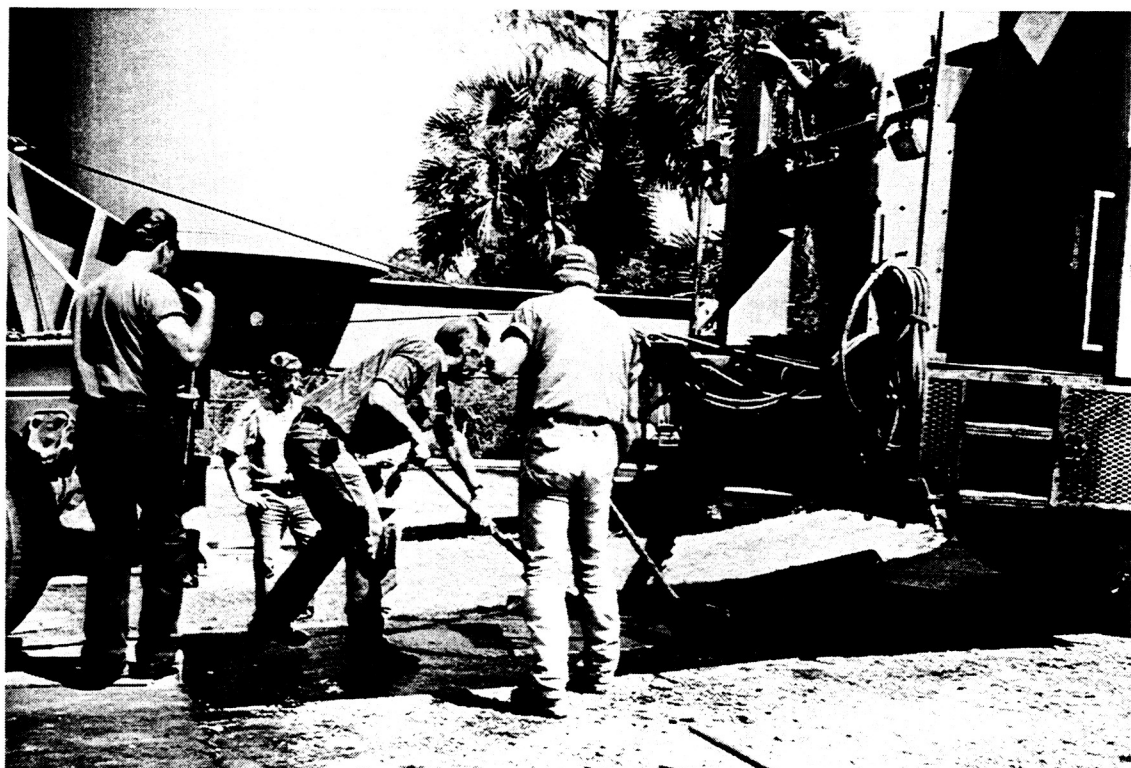
Photograph 4.13: BERGKAMP Continuous Mix Paver placing GRIPLAST.

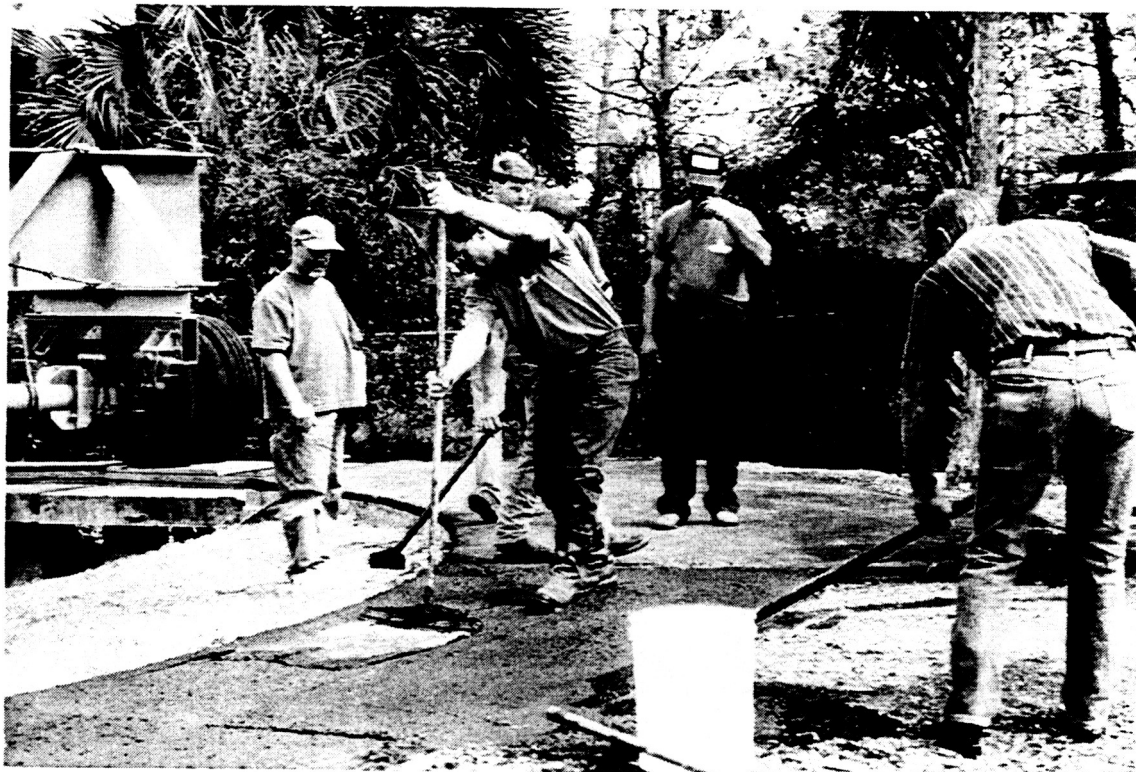
Photograph 4.15: GRIPFIBRE being handworked with rake and burlap floated.

GRIPFIBRE, with an estimated 3 lb/ton (1.5 kg/tonnes), 0.15% by wt. of agg., of polyacrylonitrile fiber in the mix was poured on the section in the same fashion as **GRIPLAST** (see Photograph 4.15).

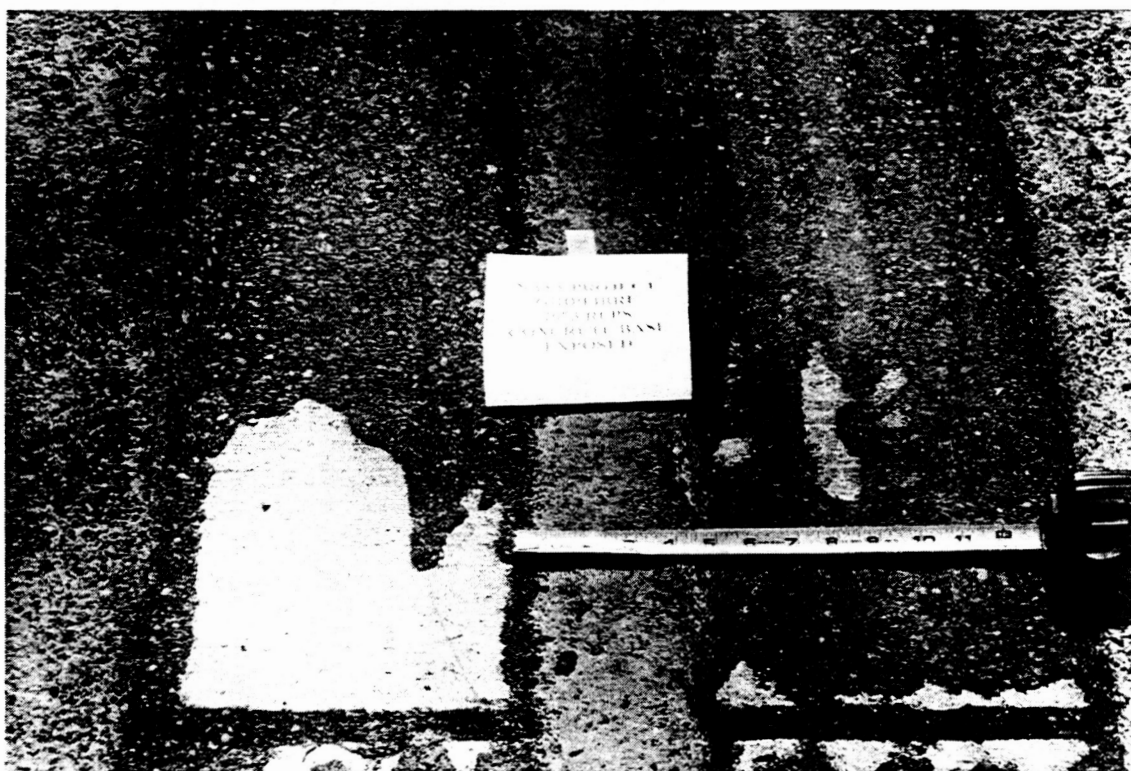
Photograph 6.2: GRIPFIBRE microsurfacing section @ 2,673 reps

Photographs 6.1 and 6.2 show the early problems of the pavement section after approximately one hour (938 reps) of testing. The photos exhibit that the material has been worn off and rutted, printed with tire tread, and that the concrete slab underneath has been exposed. Deterioration started under the inner wheel path and then extended to the outer wheel path (after approximately 2.6 hour or 2,673 reps). After approximately six hours (6,161 reps), at other locations the material continues to be worn off and rutted under both wheel paths as shown in Photograph 6.3. The distress worsens, exposing more concrete slab as shown in Photograph 6.4, as well as ravelling and aggregate polishing after approximately 21 hours (20,864 reps). From Photograph 6.5, after almost 35 hours (34,306 reps) of testing, large areas of the pavement section were completely worn off underneath the wheel paths. Also, the photo shows material uplift between the dual-tires and along the outside edge of each tire. After nearly 46 hours (46,135 reps) of testing the paving material was clearly uplifted, ravelled, rutted, and the aggregate polished as shown in Photograph 6.6.

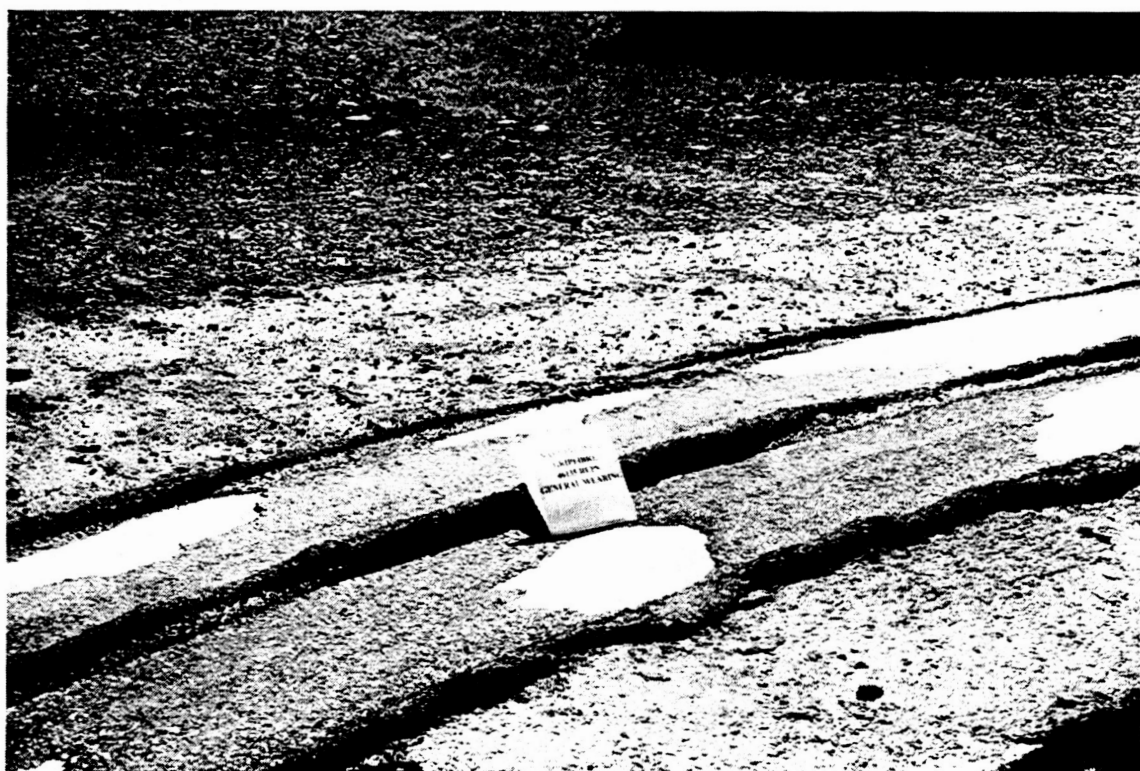
Photograph 6.6: GRIPFIBRE microsurfacing section @ 46,135 reps

The GRIPLAST performed the same problems in the early stages, as with GRIPFIBRE (see Photographs 6.7 and 6.8). After approximately 7.6 hours (7,684 reps), the material continues to be worn off and rutted under both wheel paths at other locations as shown in Photograph 6.9. The distress even worsens after approximately 29 hours (28,890 reps) (see Photograph 6.10). Photograph 6.11 displays the same distress as Photograph 6.6 of GRIPFIBRE.

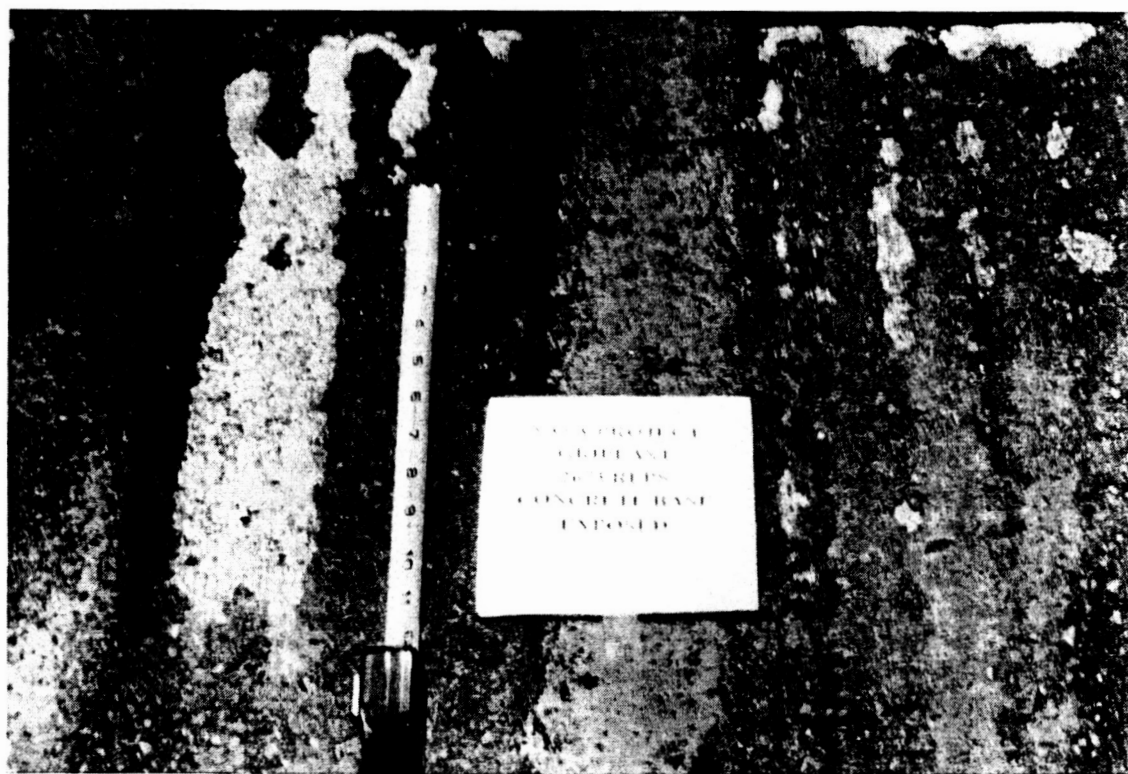
Photograph 6.7: GRIPLAST microsurfacing section @ 938 reps

Photograph 6.8: GRIPLAST microsurfacing section @ 2,673 reps

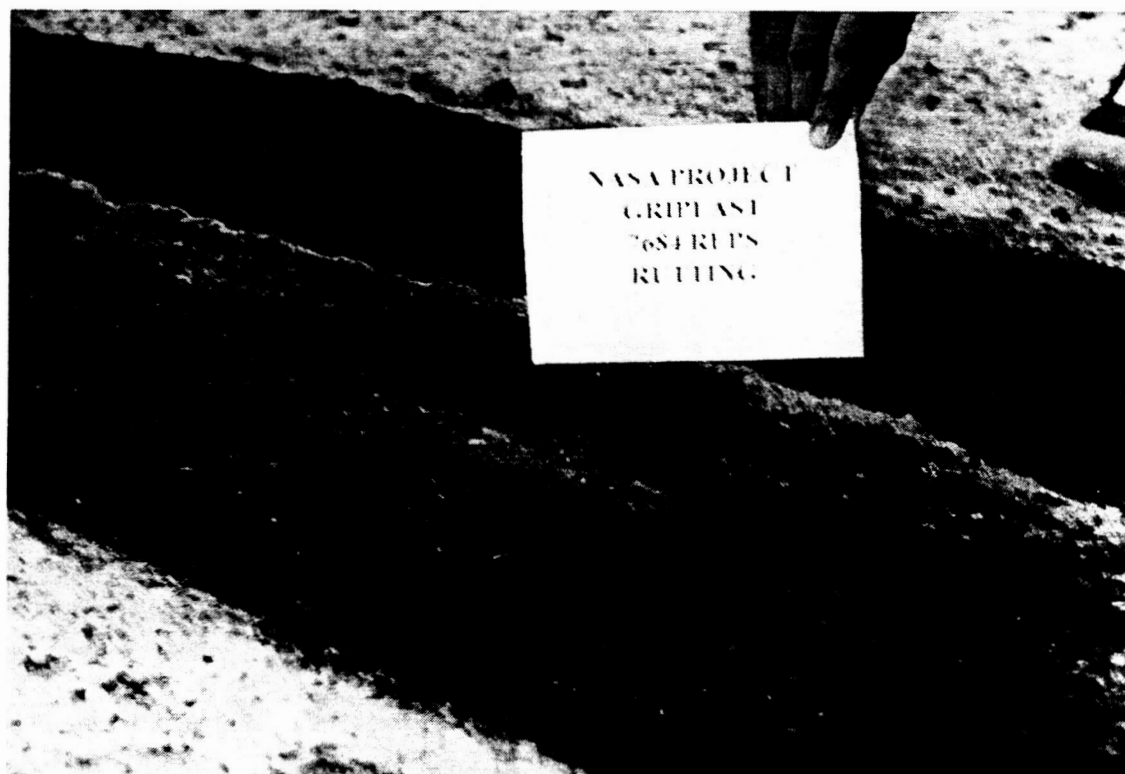
Photograph 6.9: GRIPLAST microsurfacing section @ 7.684 reps

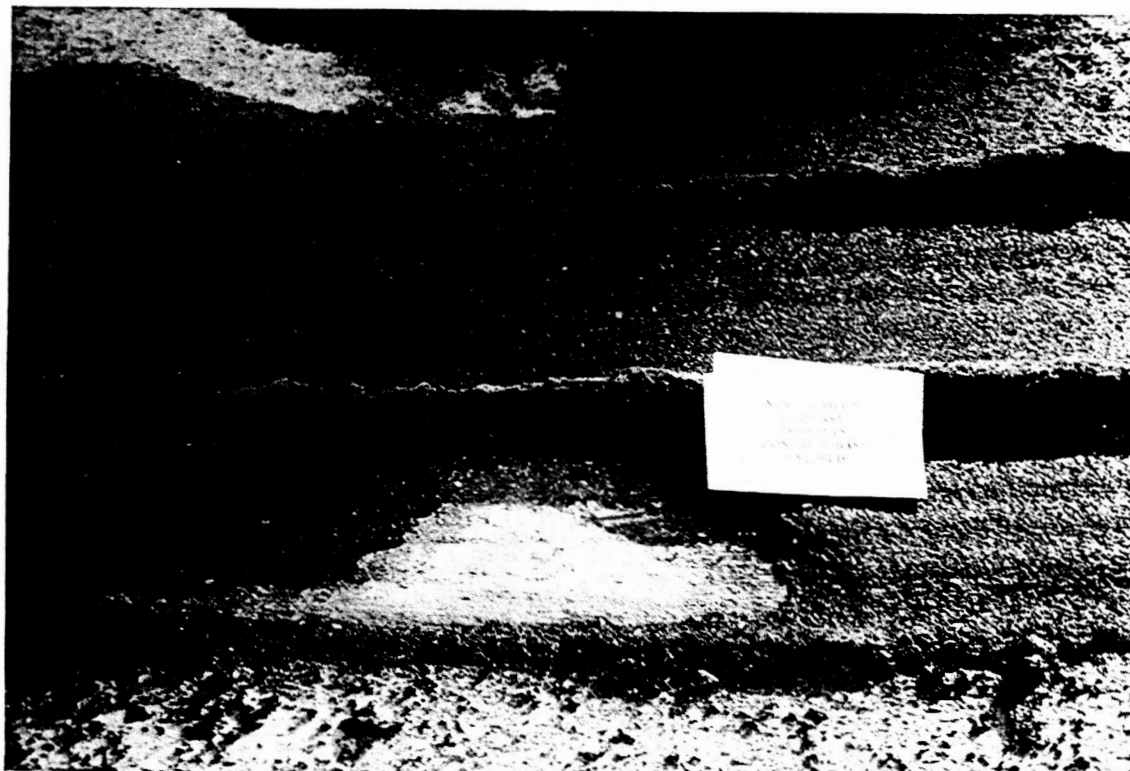
Photograph 6.10: GRIPLAST microsurfacing section @ 28,890 reps

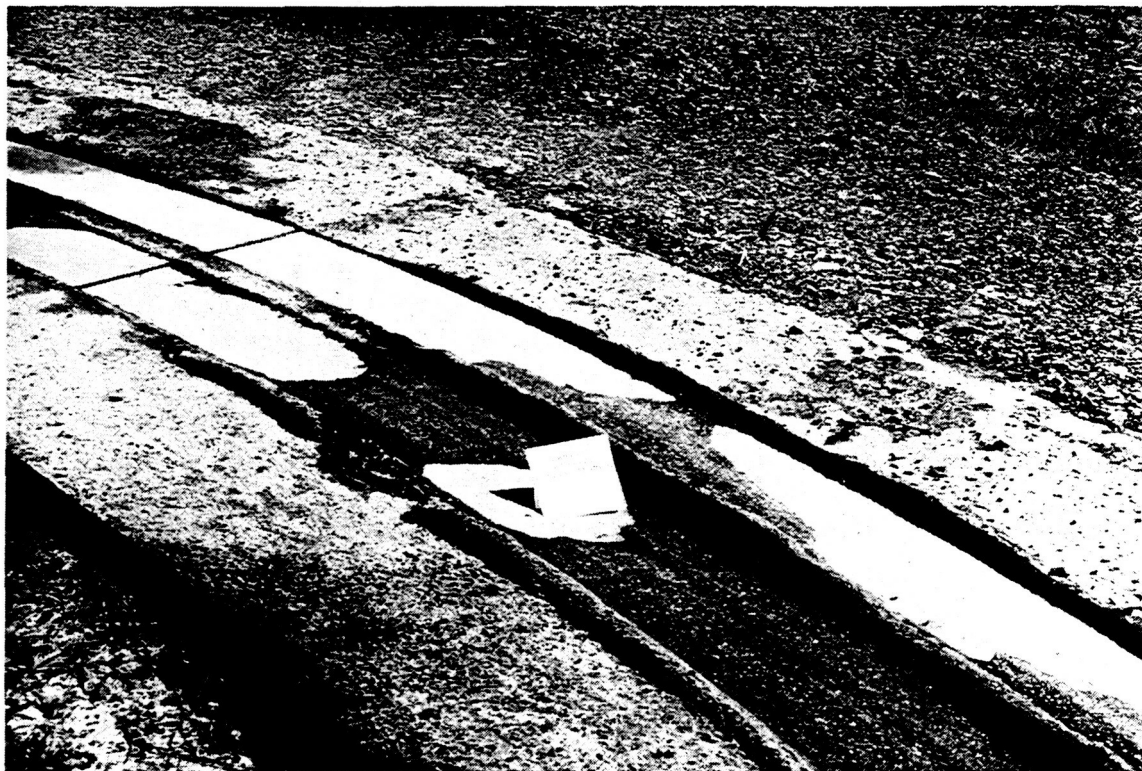
Photograph 6.11: GRIPLAST microsurfacing section @ 46,135 reps

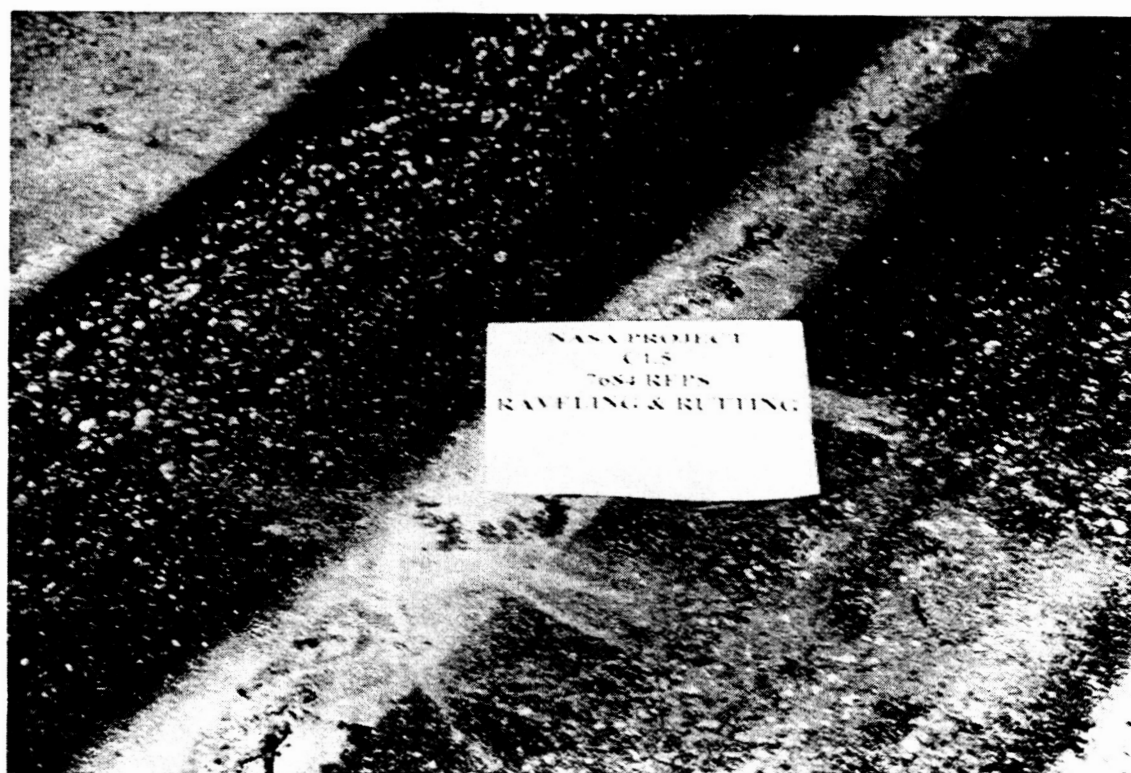
Photograph 6.13: Conventional section C1.5 @ 7,684 reps

For the C1.5 pavement section, after nearly 2.6 hours (2,673 reps) of testing shows some aggregates polished (Photograph 6.12) under both wheel paths. After approximately 7.6 hours (7,684 reps), the material experiences more polished aggregate with some ravelling and rutting, largely under the inner wheel path as seen in Photograph 6.13. Photograph 6.14 indicates more of the same after almost 29 hours (28,890 reps), except that at this location more distress occurs under the outer wheel path. Photograph 6.15 indicates worsening polished aggregate, ravelling, deeper rutting and material uplift at the tire edges especially under the outer wheel path after 46 hours (46,135 reps) of testing.

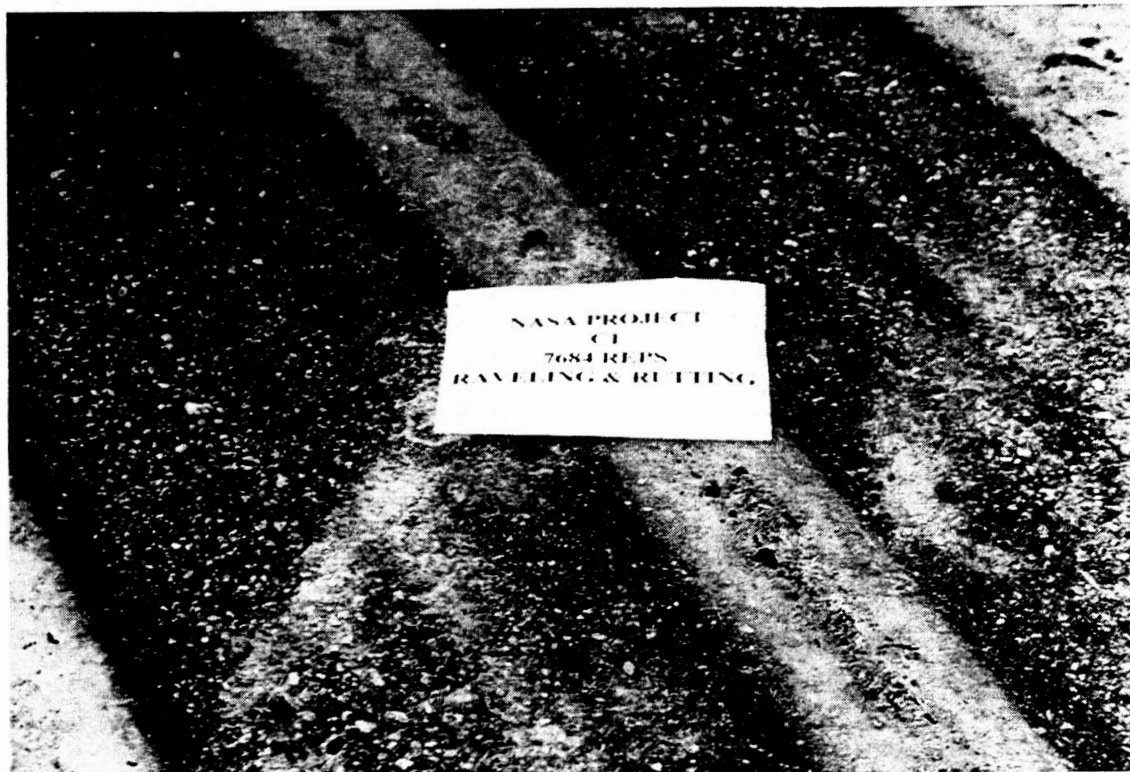
Photograph 6.16: Conventional section C1 @ 7,684 reps

For the C1 pavement section, after 7.6 hours (7,684 reps) of testing some polished aggregates were revealed under both wheel paths (Photograph 6.16). Photograph 6.17 shows more polished aggregate as well as rutting under the outer wheel path after almost 21 hours (20,846

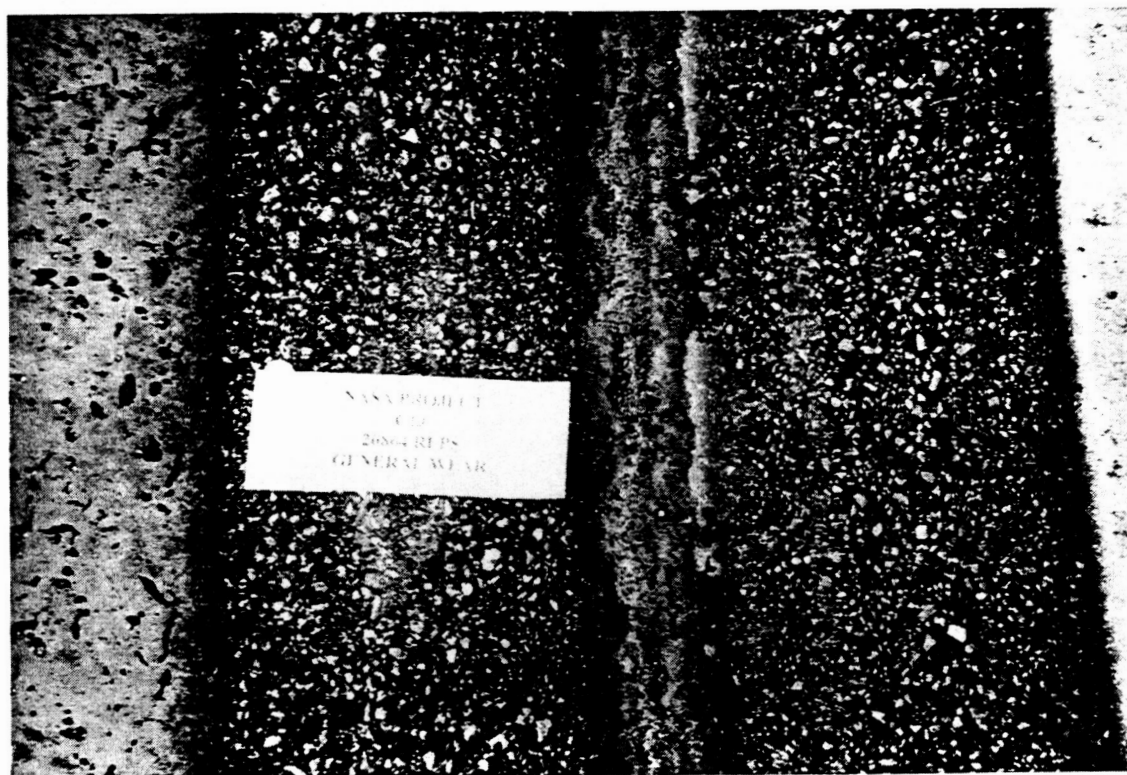
Photograph 6.17: Conventional section C1 @ 20,864 reps

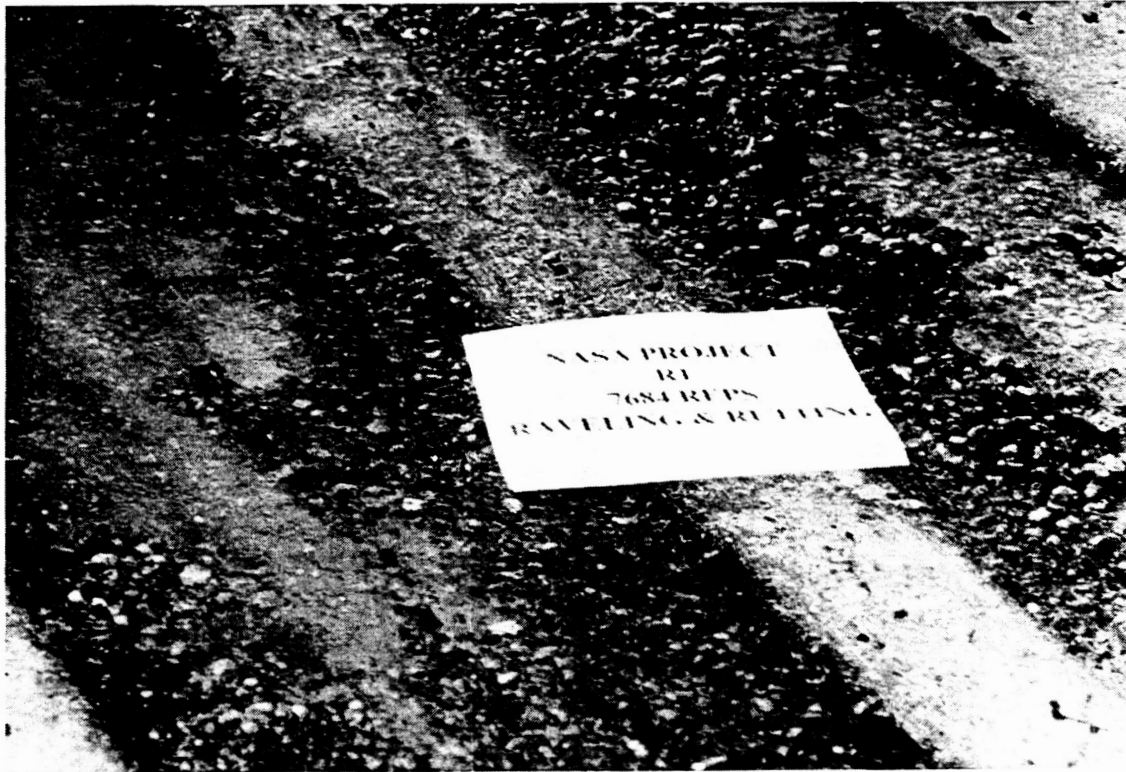
Photograph 6.24: Rubberized section R1 @ 7,684 reps

For the R1 pavement section, after nearly 7.6 hours (7,684 reps) Photograph 6.24 indicates a location of some ravelling and rutting under both wheel paths. Photograph 6.25 shows polished aggregate under both wheel paths and rutting under the outer wheel path after nearly 21 hours (20,864 reps). Photograph 6.26 shows a worsened polished aggregate and ravelling occurring under the inner wheel path after almost 29 hours (28,890 reps) of testing. After approximately 34 hours (34,306 reps) Photograph 6.27, which is mislabeled in the photo, shows a location 4"x12" (10.2 cm x 30.5 cm) of severe ravelling and rutting such that the concrete base is exposed under the outer wheel path. Photograph 6.28 is the same location as Photograph 6.27, except that the 4"x12" (10.2 cm x 30.5 cm) area had been patched with an epoxy-type material, it indicates that after approximately 46 hours (46,135 reps) of further testing more concrete base was exposed 4"x10" (10.2 cm x 25.4 cm) on both sides of the patch under the outer wheel path. For the same time period of 46 hours Photograph 6.29 shows another location where polished aggregate, ravelling, and rutting occurred. After almost 52.5 hours (52,578 reps) Photograph 6.30 shows the same location of photo 6.27 except an area 8"x18" (20.3 cm x 45.7 cm) under the inner wheel path where the concrete base is exposed. Photograph 6.31 indicates another location 3"x9" (7.6 cm x 22.8 cm) where the concrete base is exposed under the outer wheel path as well as rutting and material uplift.

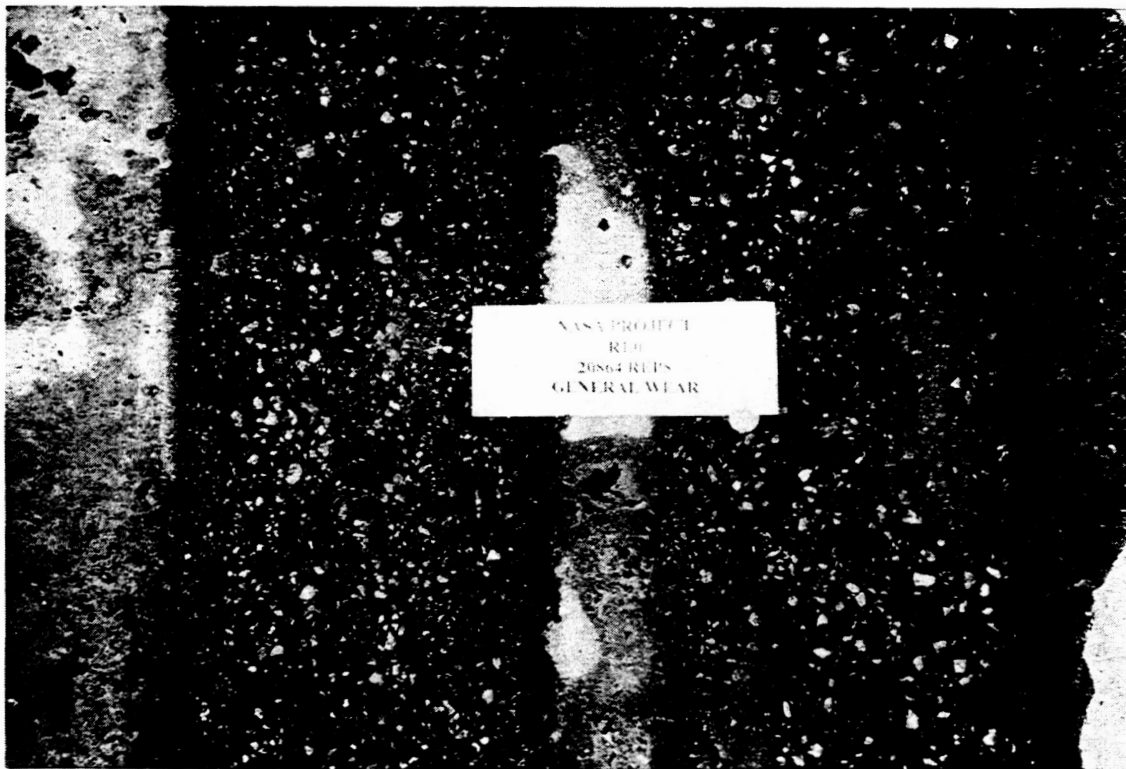
Photograph 6.25: Rubberized section R1 @ 20,864 reps

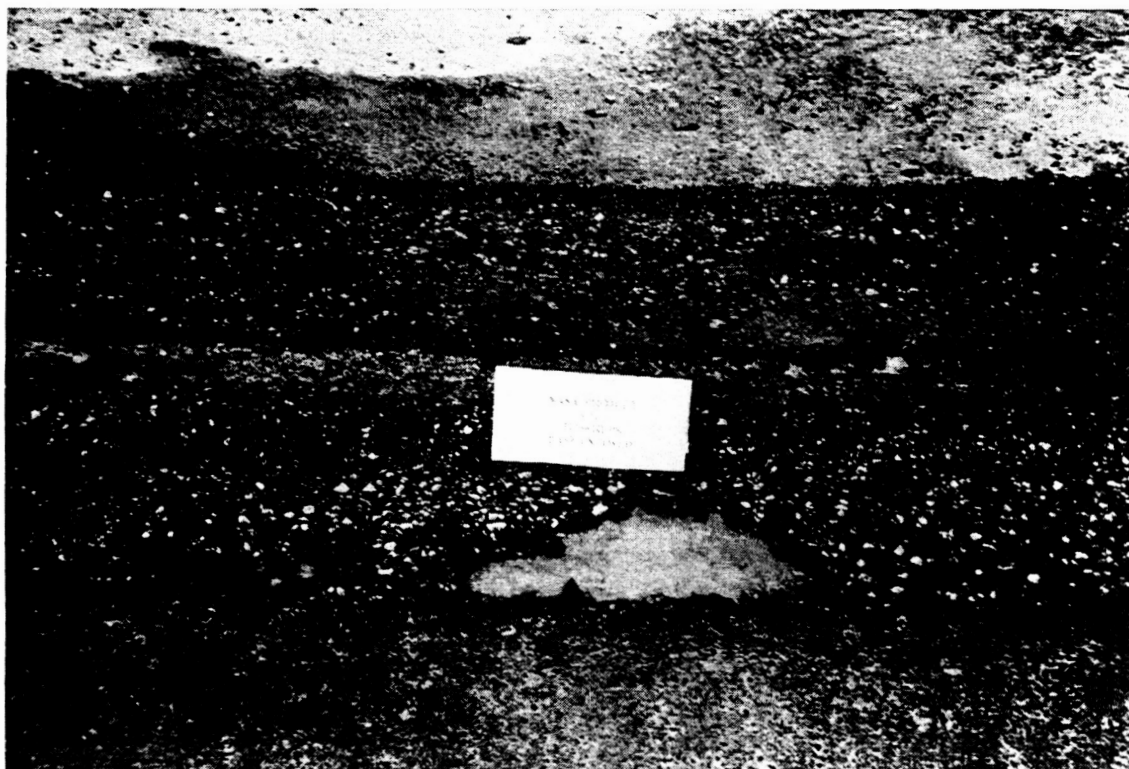
Photograph 6.27: Rubberized section R1 @ 34,306 reps (misabeled in photo)
